The Permanent Solution For Rotten Posts

POST REPLACEMENT

step-by step guide

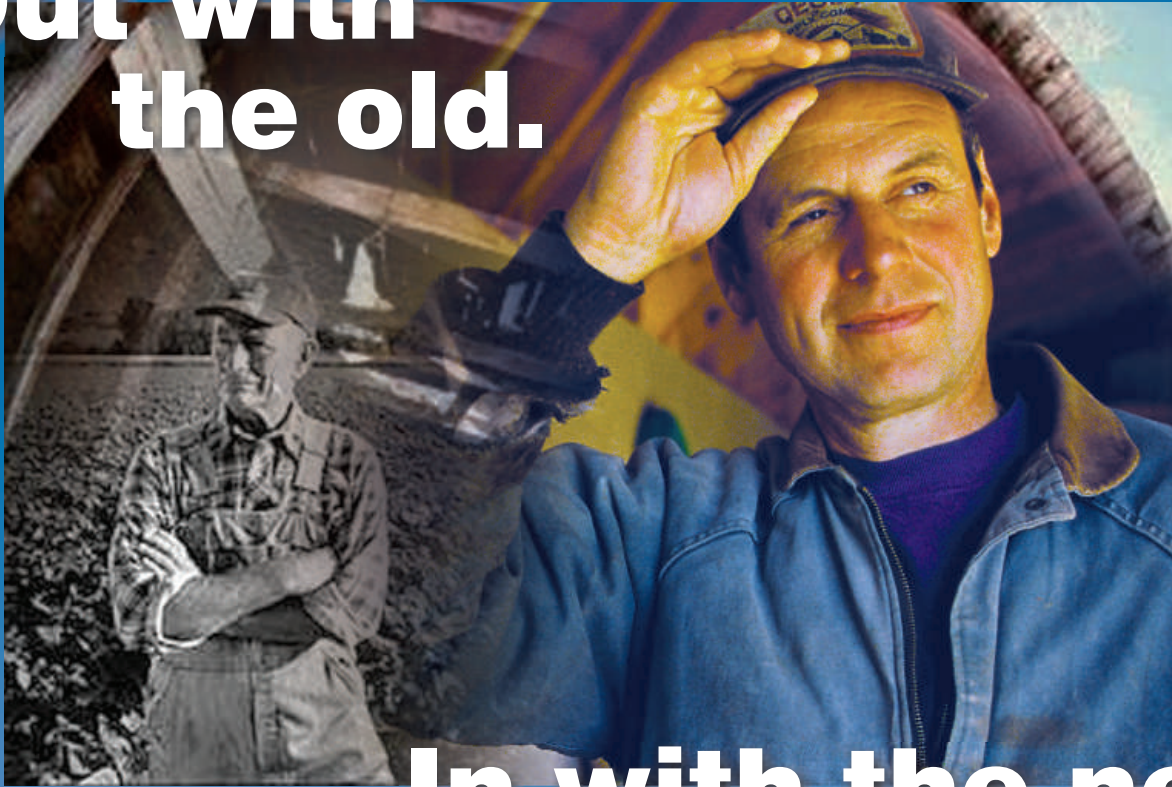
Out with the old.

In with the new!

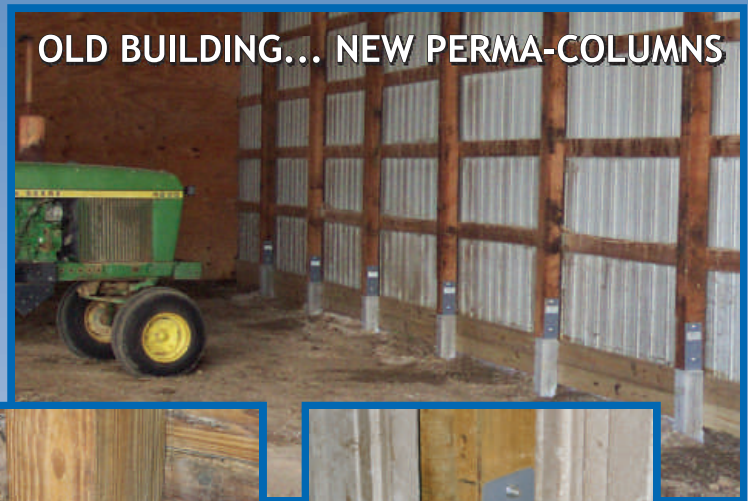
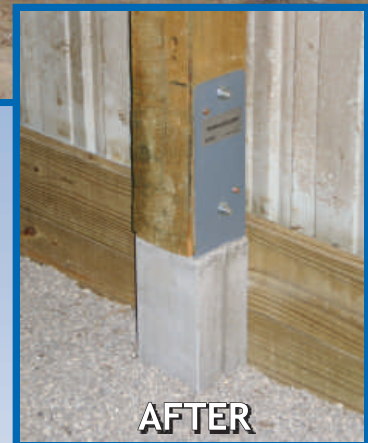
The same pre-cast technology available in new construction can now be used to repair rotten posts. Don't let deteriorated posts compromise a building with many useful years left in it! The PC4600 & PC6600 are a long awaited answer to an old and ongoing problem.
